PRODUCT BULLETIN (PBN1043-02)
November 30, 2010

Products Affected: WPT-800-RWAL (rev. 16 – 22),
WPT-800-RWAL24V (rev. 1 – 8), WPT-800-HUSB (rev. 17 – 20)

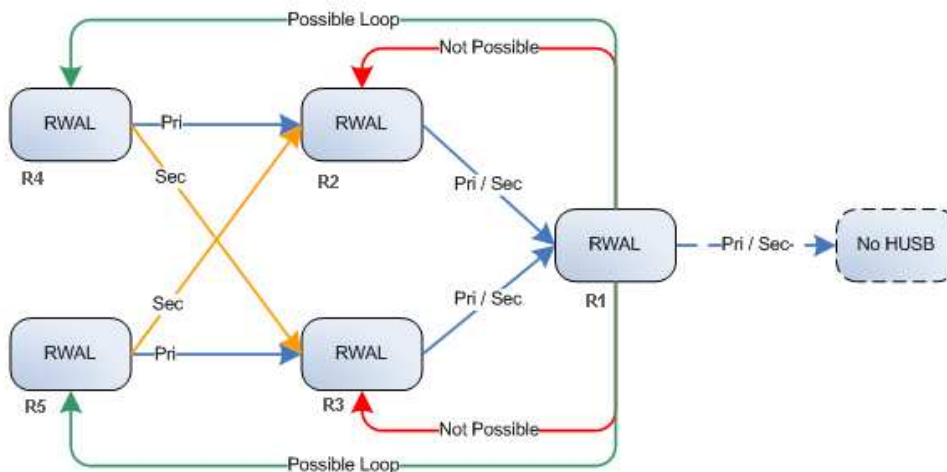
Figure 1. Sample HUSB and repeater layout

Under certain conditions, the repeaters can potentially re-organize to create a wireless loop. This loop will prevent WPT data from reaching the HUSB.

Once the HUSB regains power, all repeaters should be powered off, then they should be turned back on starting with R1 then R2 and R3, then R4 and R5.
