Retrofitting Legacy Pneumatic Controls

Overview for Hospitals

6/20/2023

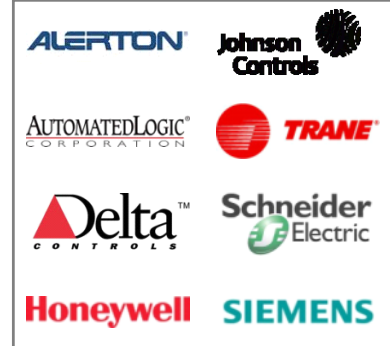
BACnet interface compatible with:

Legend

- Wired Ethernet
- LoRaWAN Wireless
- WPT Wireless Pneumatic Thermostat

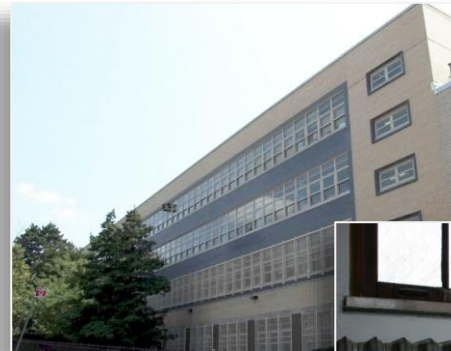
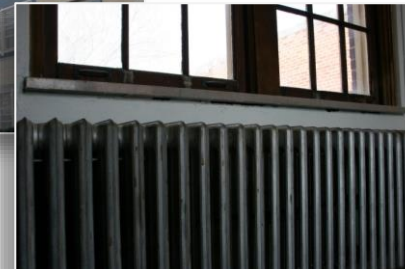
- Edward Hart Middle school Queens, NYC
- Uses Oil Fired Boilers, hot water radiators
- Fault detection, example:
 - Radiator hot water valve stuck open
 - Undetected probably many years
 - Occupants open window to compensate
 - Maintenance staff stretched thin, no data, not aware of situation

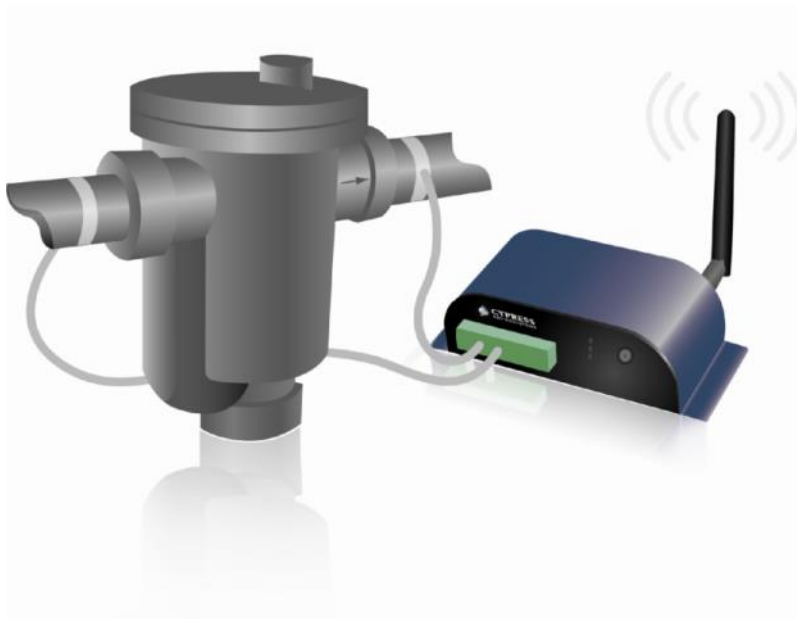
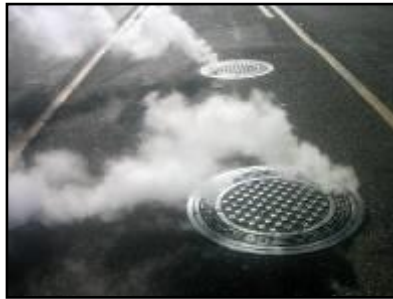
Wireless Steam Trap Monitor

- Necessary part of the steam distribution system, usually hundreds of units per site
- 15-20% average failure rate; leaks steam
- Failed traps lose \$5,000 per year (1/8" orifice)
- Manual inspection typically done annually – labor intensive, do not catch problems in timely manner
- Solution: Wireless steam trap monitor detects faults and alarms on error, avoiding expensive leak loss
- Non-invasive installation: no breaking seals, wireless, integrates with BMS
- Battery life of 3+ years at typical sample rates
- IP65/NEMA 4 rated for outdoor use
- One year payback on investment

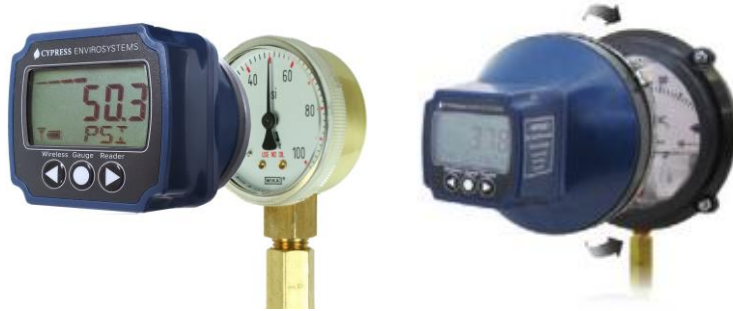
Wireless Gauge Reader

- “Electronic Eyeball” reads gauges and transmits readings wirelessly
- Non-invasive, clamp-on to existing gauges in minutes
- No downtime, no leak check, no wiring, no drawings
- Battery life of 3+ years at 15 minute sample rate
- IP56/NEMA 4 rated for outdoor use
- Various size and types of mounting adapters to fit most existing gauges
- Reads dial gauges, hour meters, LED/LCD displays

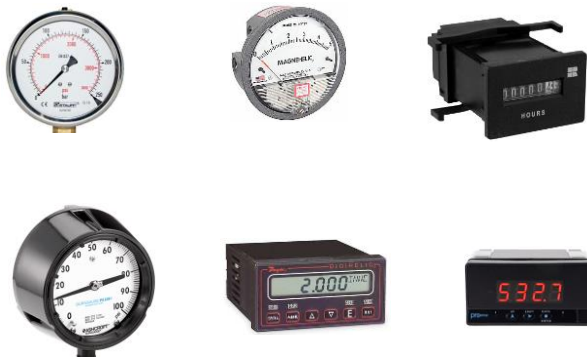
Compatible with most dial gauges, hour meters, panel meters:

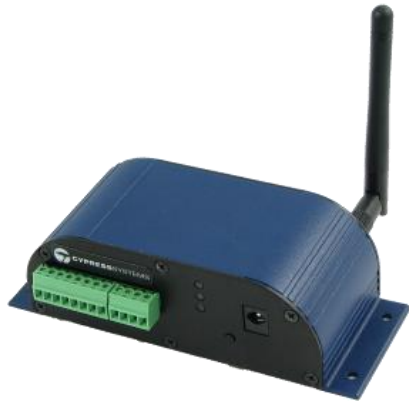
Wireless Transducer Reader

- Enables wireless remote monitoring of virtually any analog transducer or instrument with the following outputs: 4-20mA, 0-5V, or 0-10V, RS-232, RS-485, thermocouple, thermistor
- Compatible with most existing flow meters, current meters, particle counters, thermocouples, weigh scales, etc.
- Battery life of 3+ years at 15 minute sample rate
- Optional enclosures for NEMA 6, IP 67 protection
- Enables data logging to enable trend analysis, notification, or statistical process control
